**APRIL 3, 2024
SUBMITTALS**

2024-COA-053 (IRV)
325 N. BOLTON AVE.

Re: 325 N. Bolton Ave.
Existing Garage Assessment

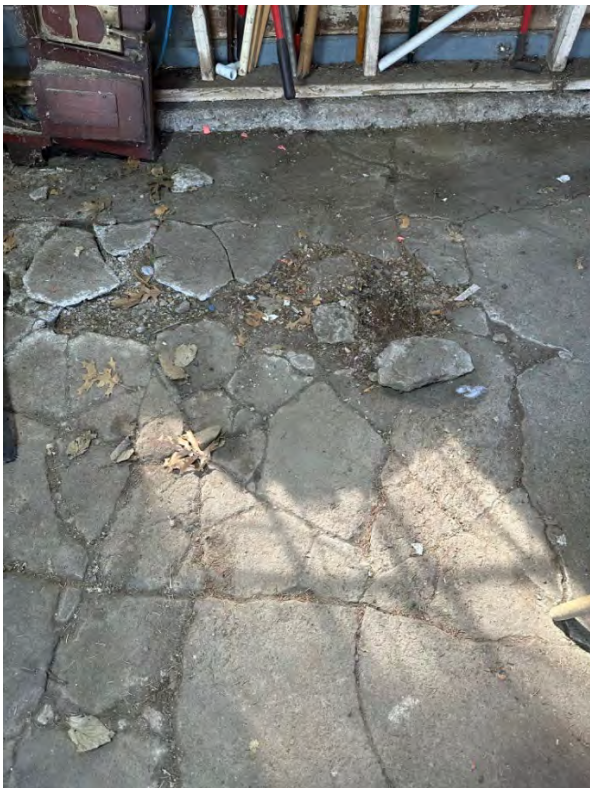
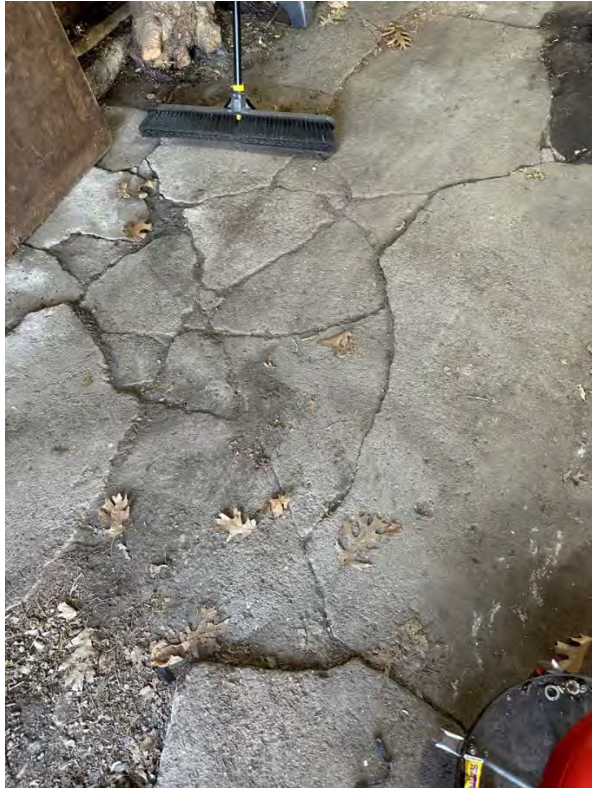
The existing garage is generally in poor condition. The concrete slab and drive apron are severely cracked and deteriorated. Several wall and roof framing members, and a good amount of wood siding boards, are split, rotted, or show evidence of termite damage. The wall sill plates in several locations are severely deteriorated. The header over the garage door is inadequate for the span and is sagging. There have been newer wood framing members added over the years to both correct deficiencies and to extend the footprint of the building, but many were done in a haphazard manner and do not adequately address the problems.

Interior Slab Conditions:

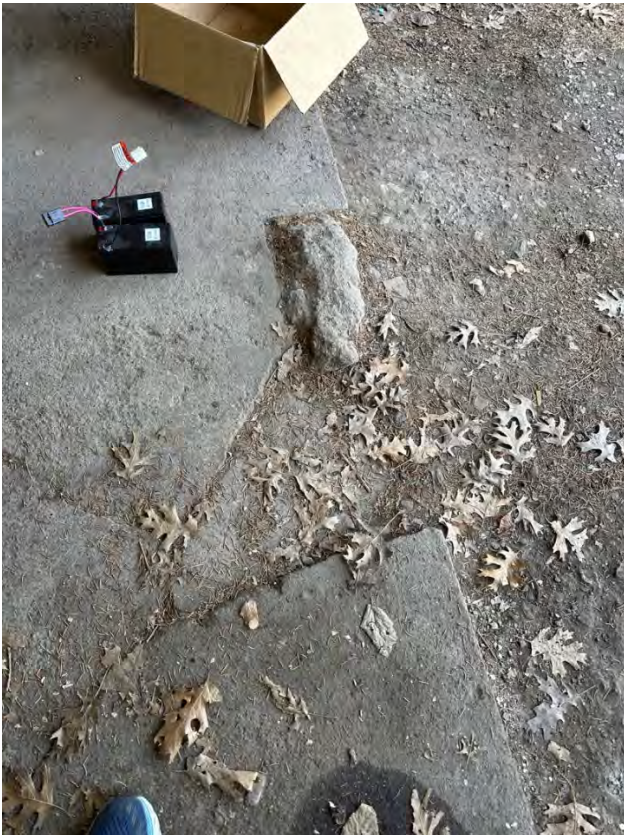
Slab doesn't extend to added construction:

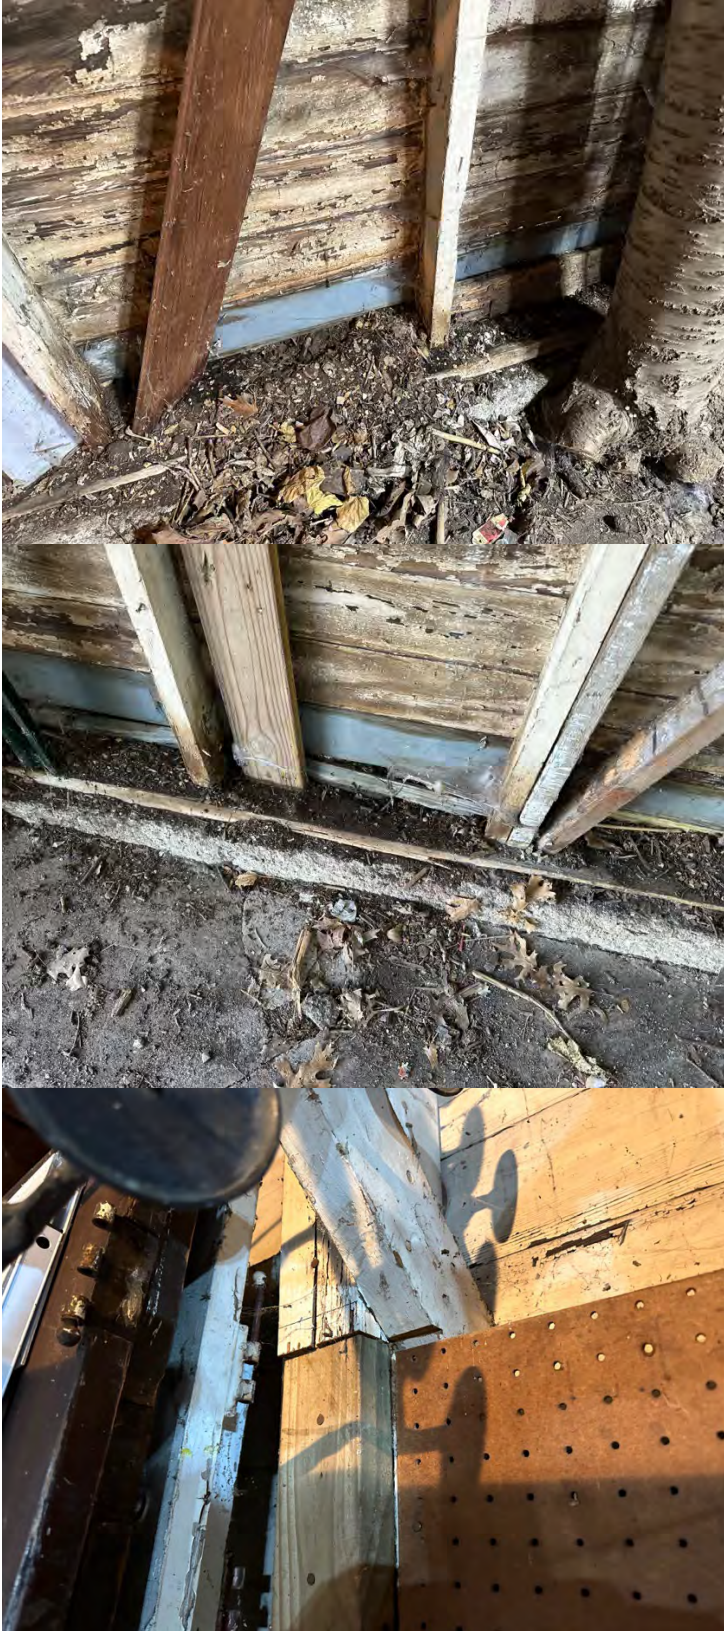
East Wall condition displaying termite damage to frame, rotted clapboards, baseboard termite damage/rotted. Unsteady replacement pieces and additional pieces to shore up damage.

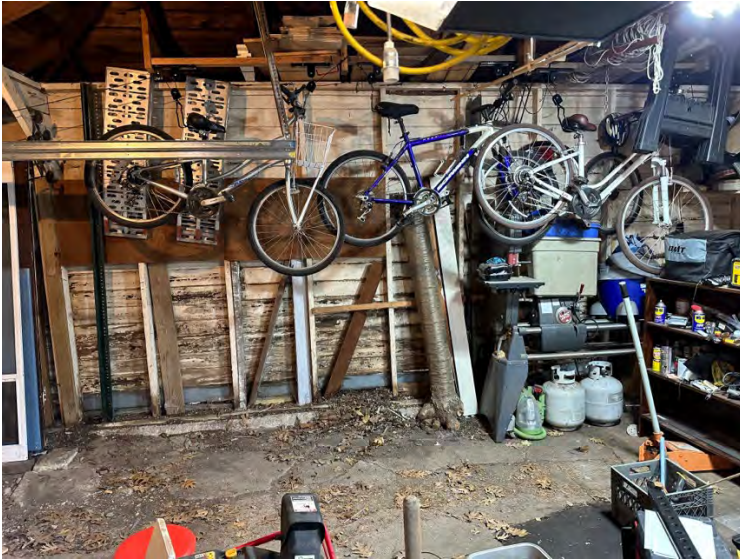
Overall view of East wall.

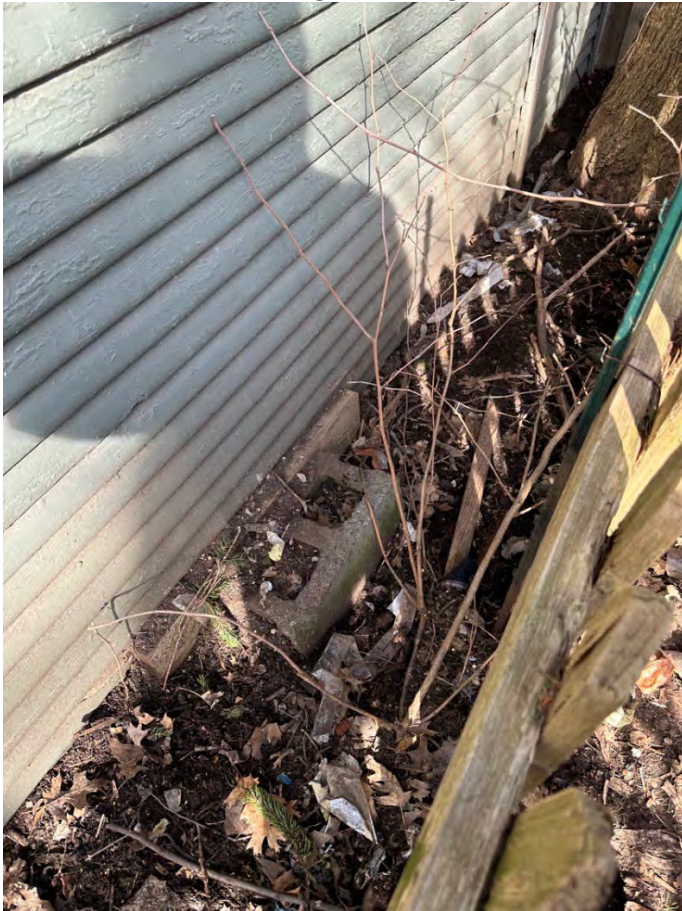
Outside of East wall, dirt against siding and holes in wall.

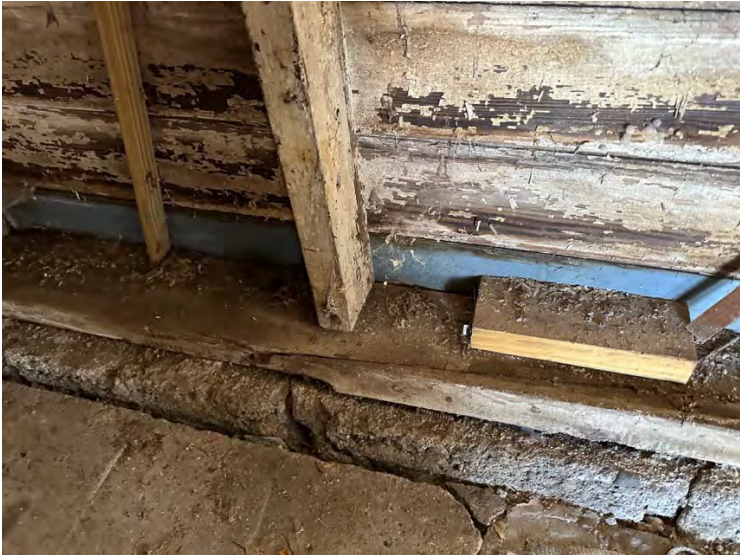
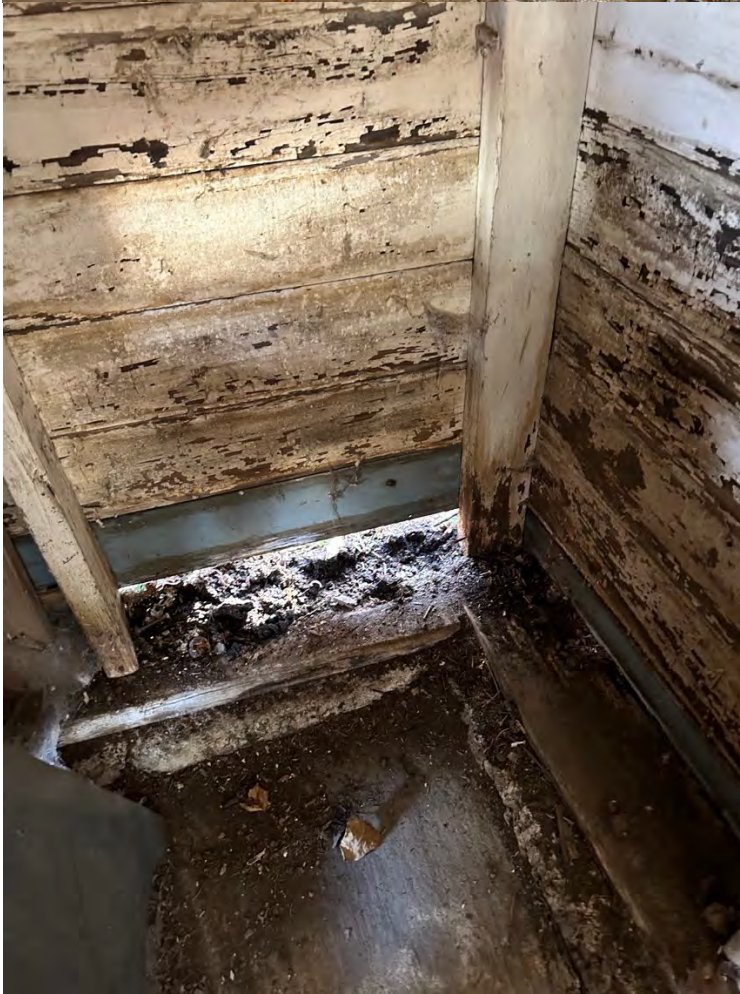
South wall crumbling foundation and remains of former support. Termite damage and rot present.

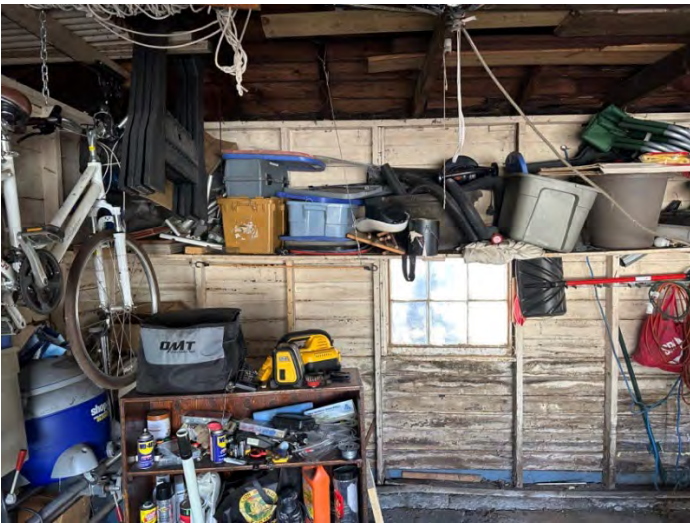
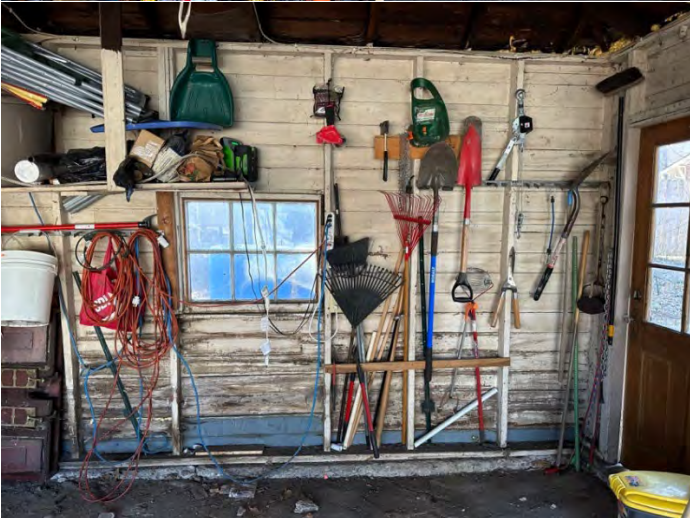
Overall view of South Wall:

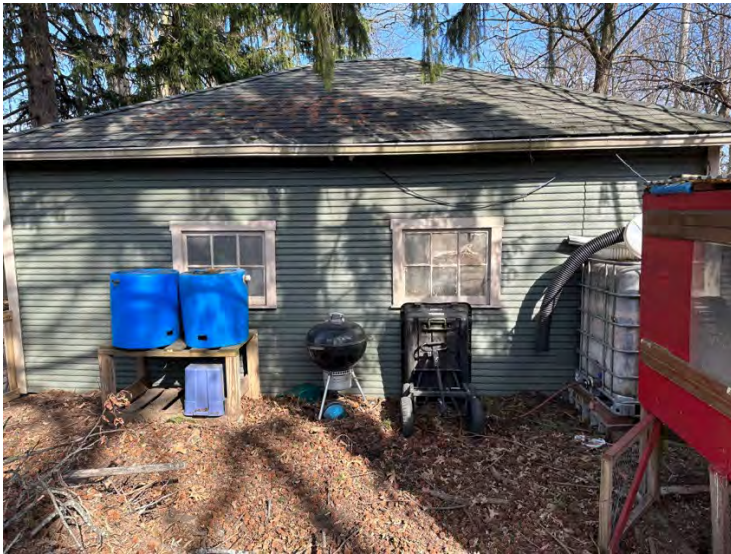
Outside view of South Wall:

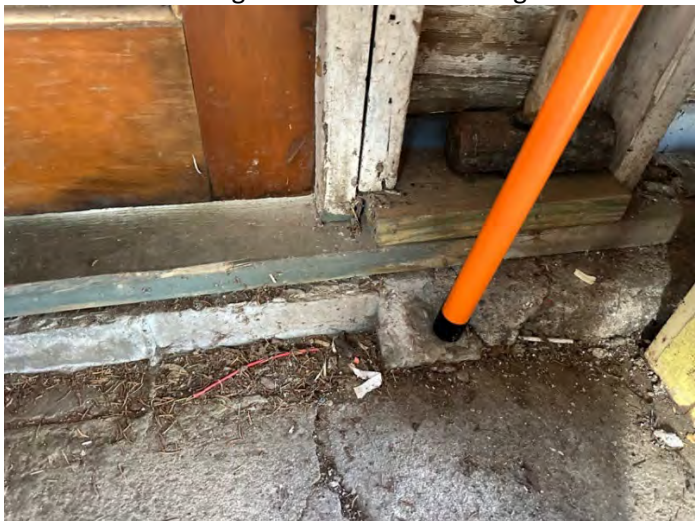
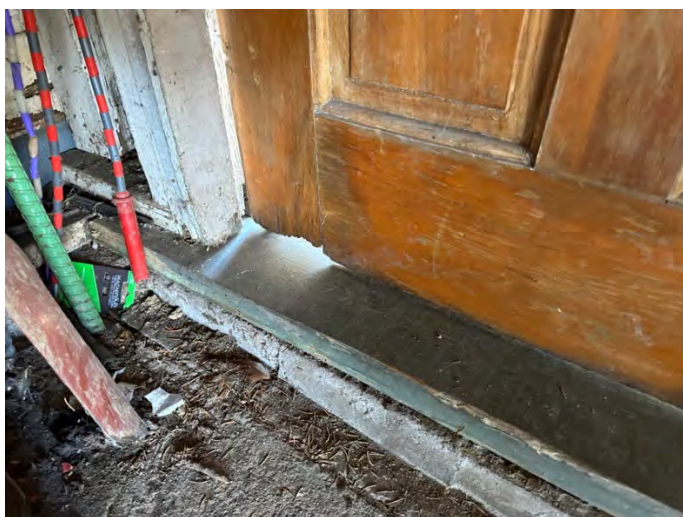
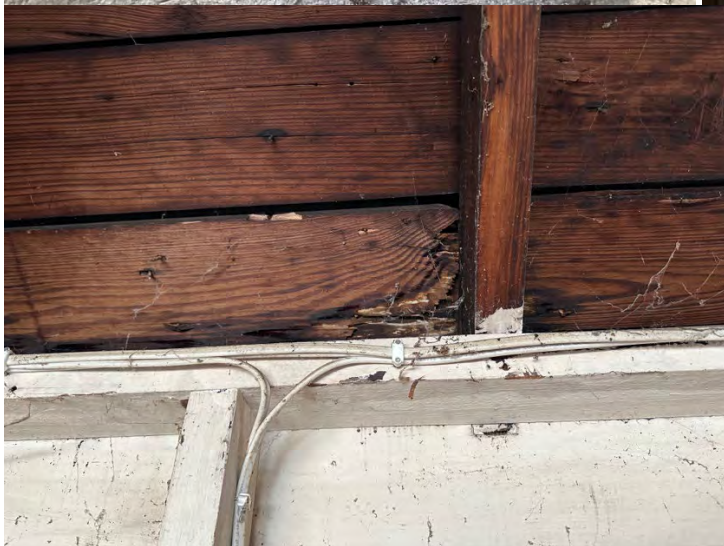
West wall crumbling foundation roof damage.

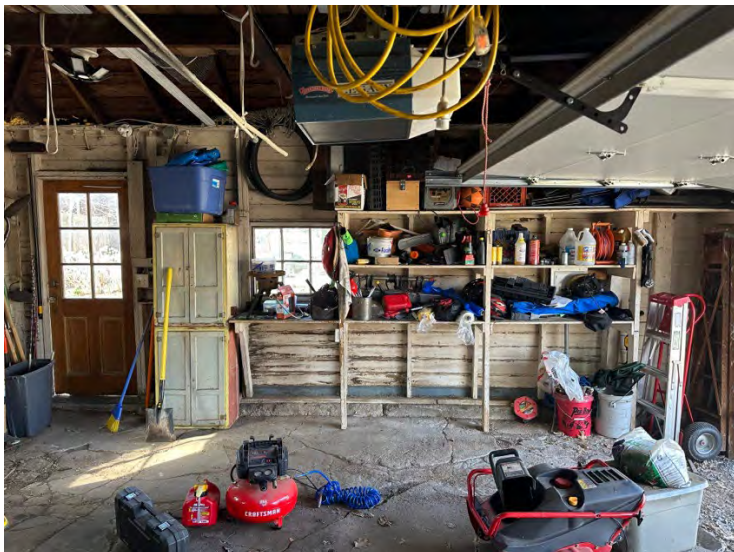
Overall view of West wall.

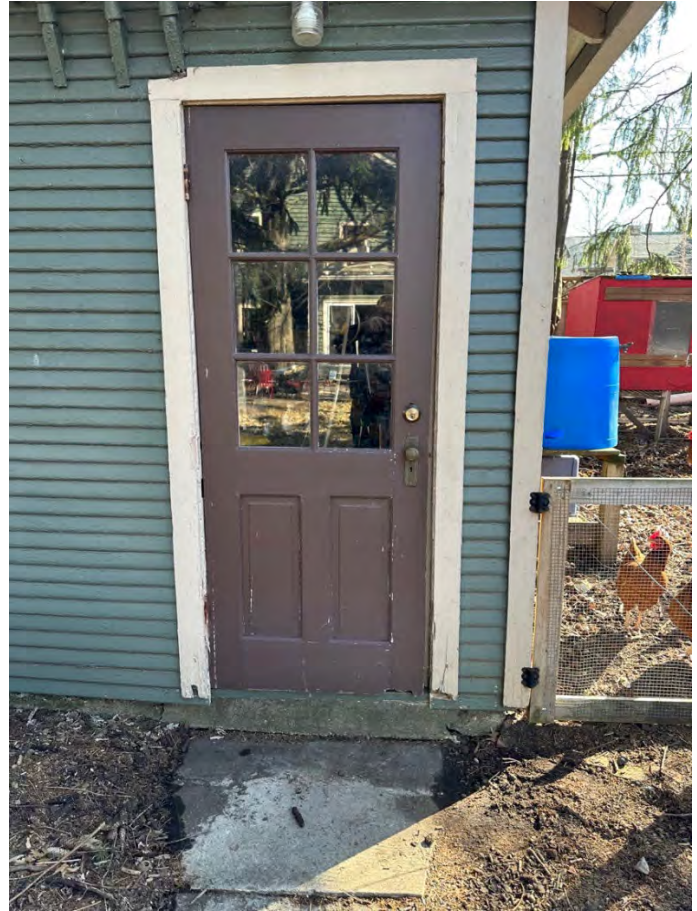
West Exterior: crumbling foundation and rotting trim.

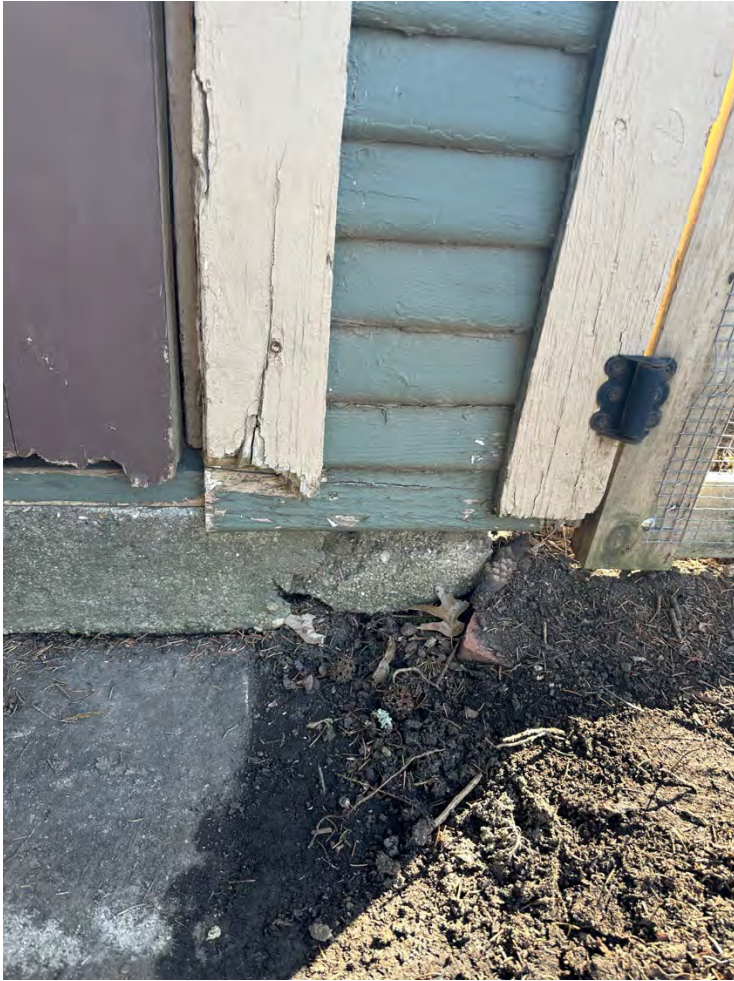
Overall exterior view of west wall.

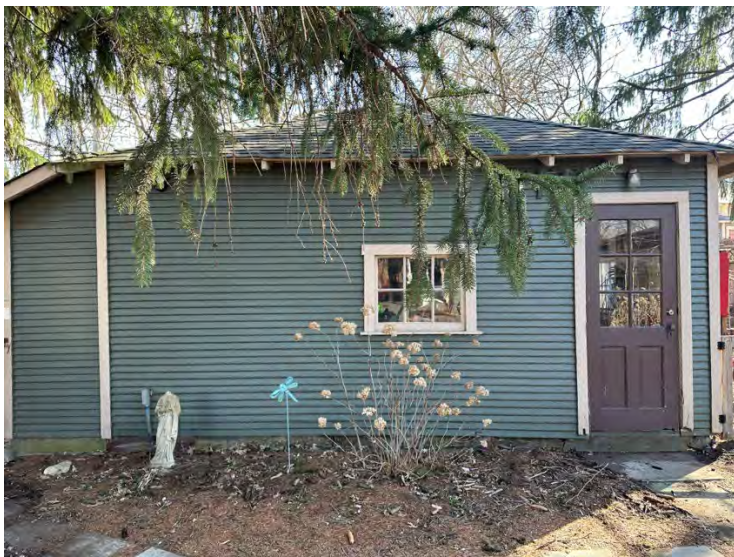
Overall view of North Wall/vehicle entrance. Uneven dirt floor and sagging structure.
