2023-COA-479 (SJ)
935 N. ALABAMA ST.

ALABAMA STREET CARRIAGE HOUSE - IHPC DOCUMENTATION

2023-COA-460B(HMP)
2059 N. ALABAMA ST.

Context for nearby retaining walls and fences (near 2059 N Alabama St - subject property)

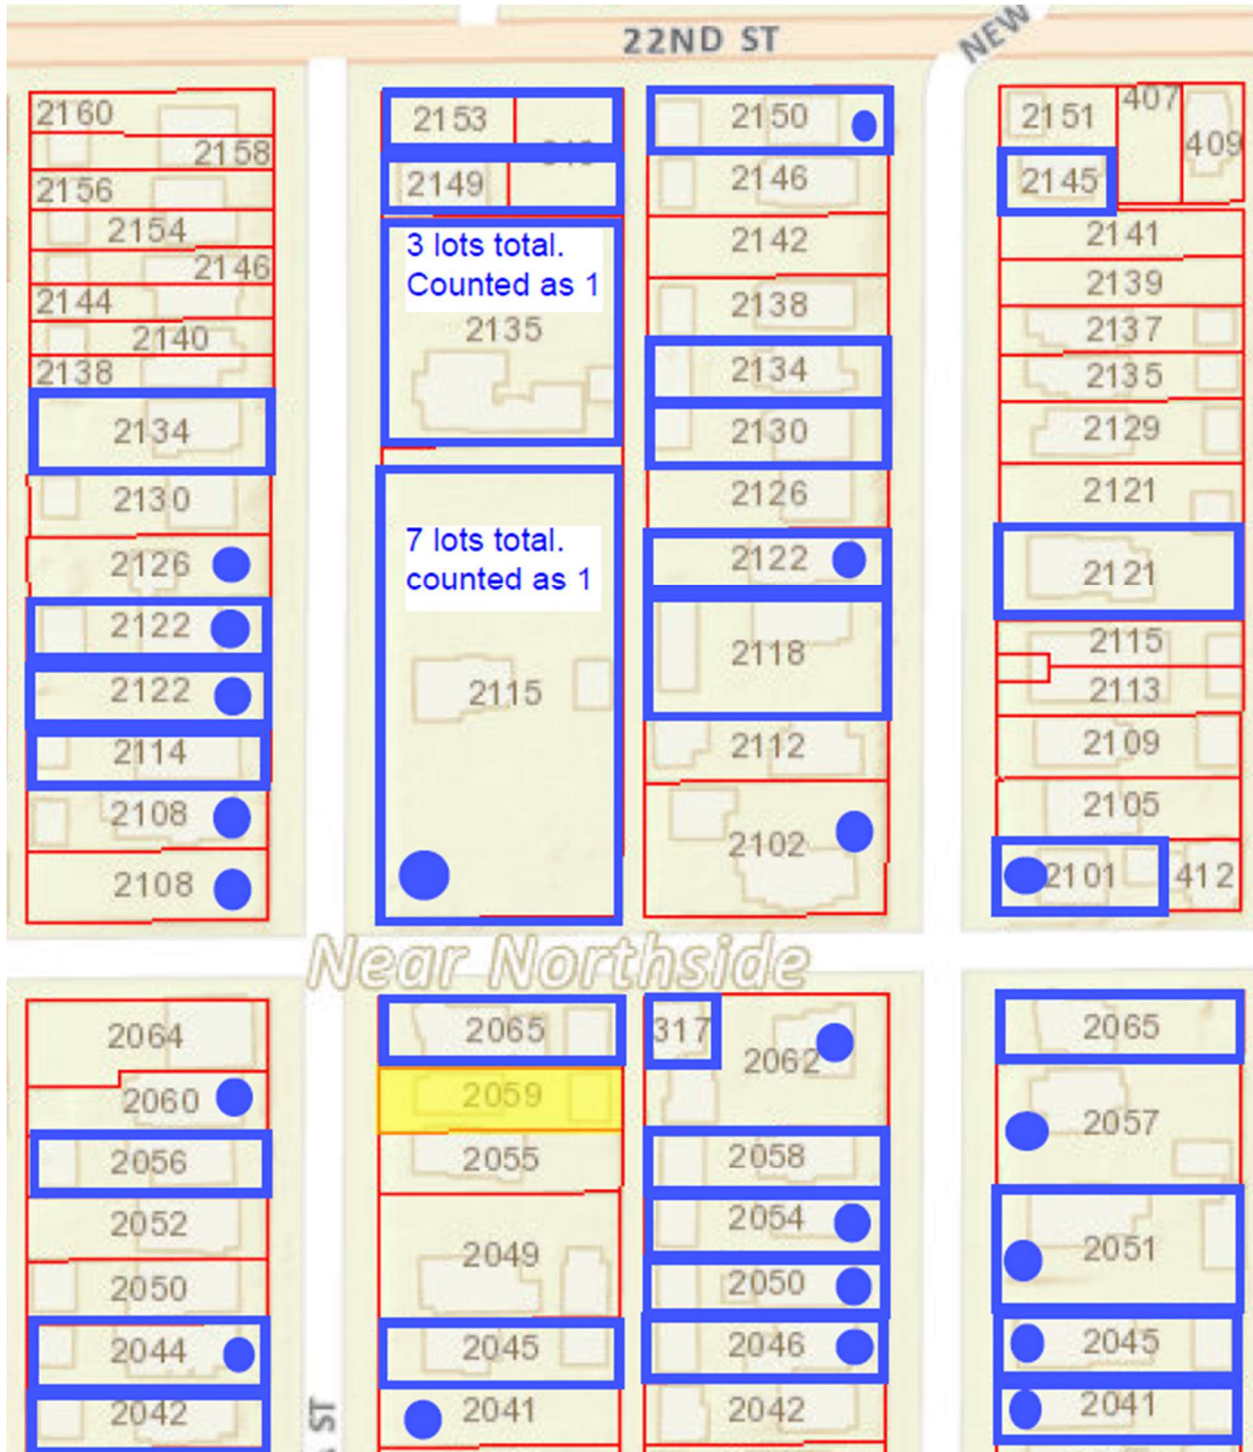
Map of area showing retaining walls (blue squares) and fences (blue dots).
Yellow highlight area is subject property.

Within a block radius of the project the majority of the surrounding properties have retaining walls, front fences or both present at the front yard. We contend that this is largely due to the topography as noted above, reflected in a higher percentage which is not found elsewhere in the Herron Morton neighborhood. See Exhibit B for a map of the immediately surrounding homes. This map demonstrates that the majority of the improved lots have retaining walls and a majority of the homes with retaining walls have fences installed at the front yard. The breakdown of the properties noted on the map are as follows:

- 62 total improved lots are shown on Exhibit B map.
- 39 properties have either a fence or retaining wall in the front yard
- 30 of the above properties have a retaining wall
- 12 of these properties have a fence and retaining wall.

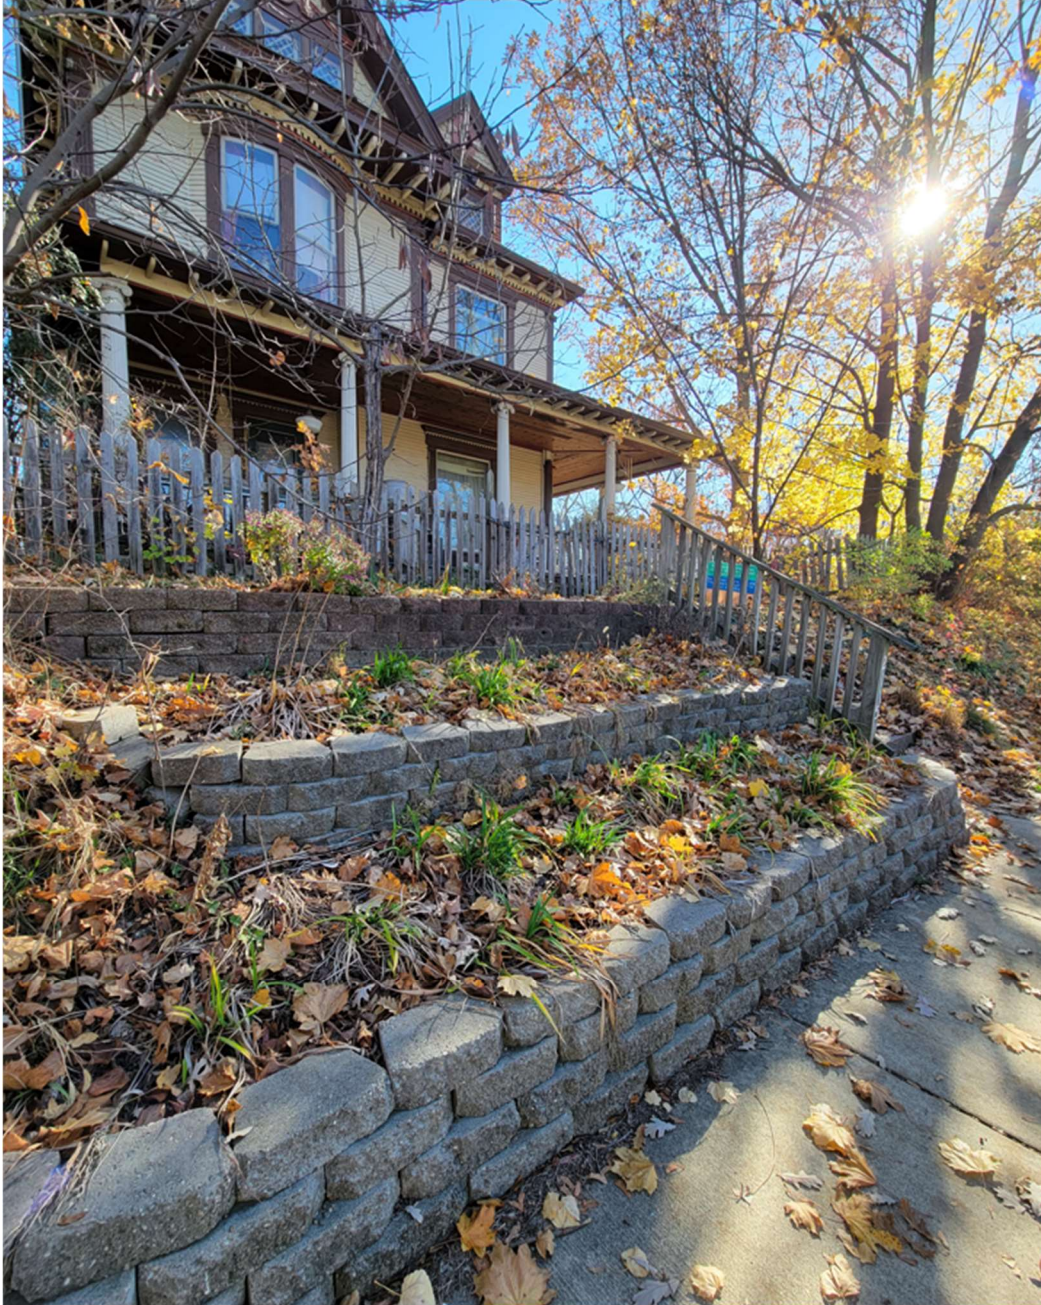
2115 N Alabama (directly north of the 21st & Alabama street intersection).
Retaining wall with (3) tiers & front fence.

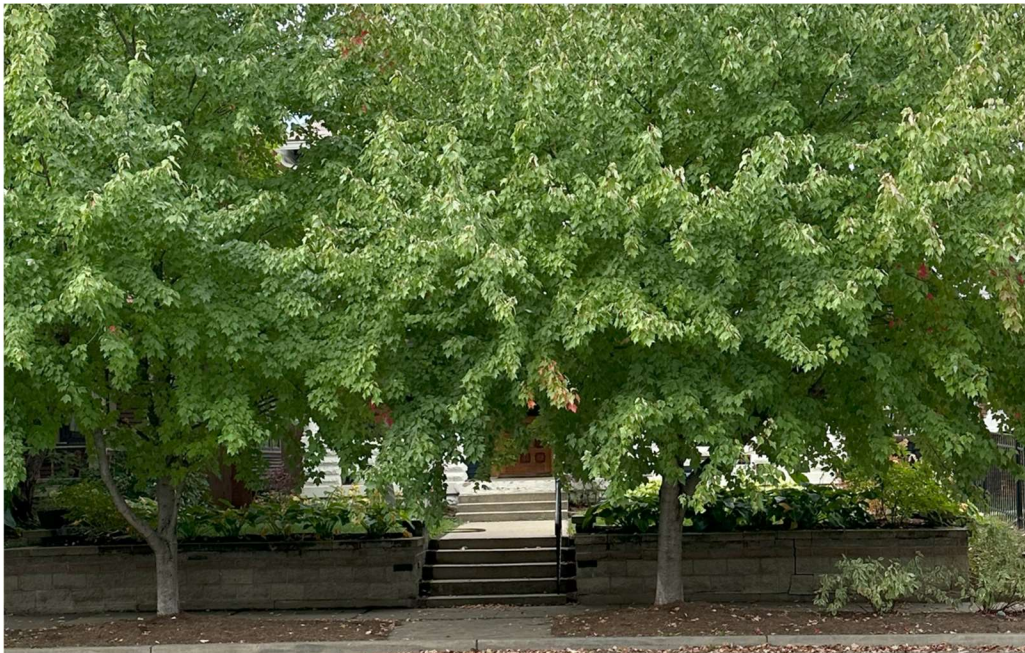
2056 N Alabama (across the street from subject property) – Retaining wall of similar size.

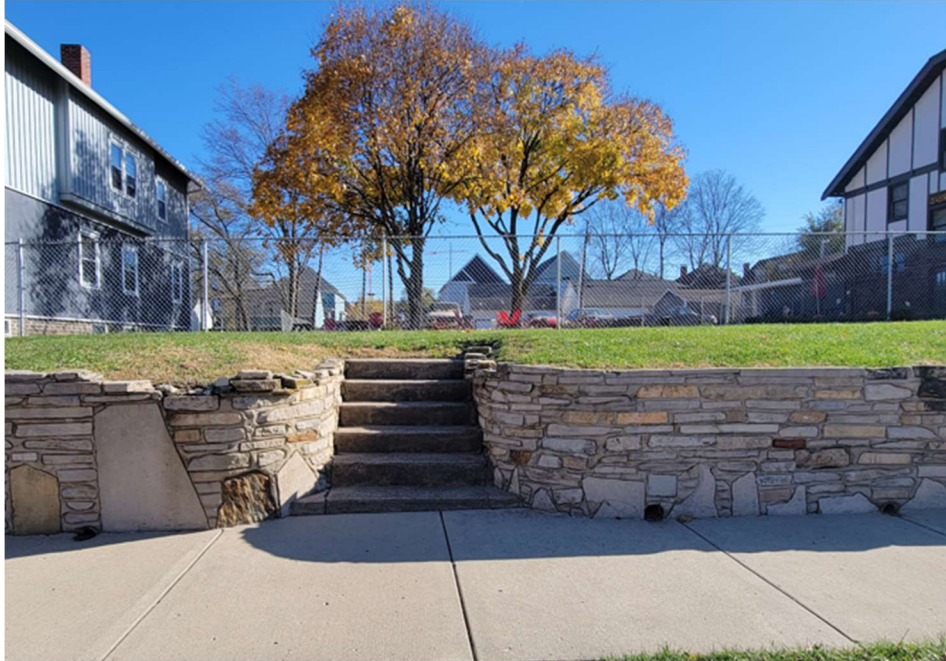
2135 N Alabama – historic retaining wall. (runs across the front of 3 lots total)

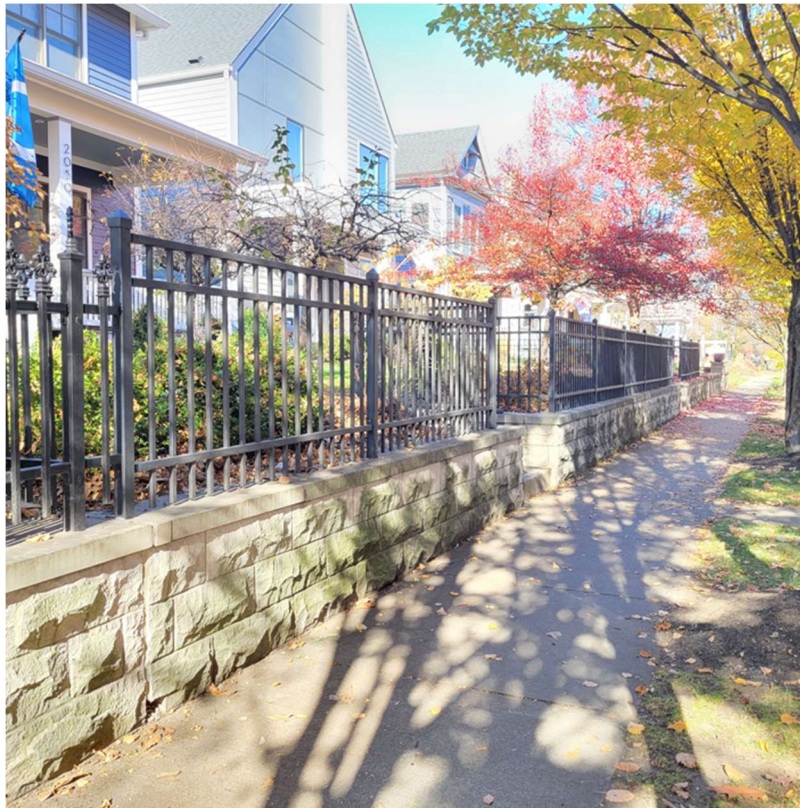
2054, 2050 & 2046 N New Jersey (directly behind subject property)
3 homes all with contiguous retaining walls and fences

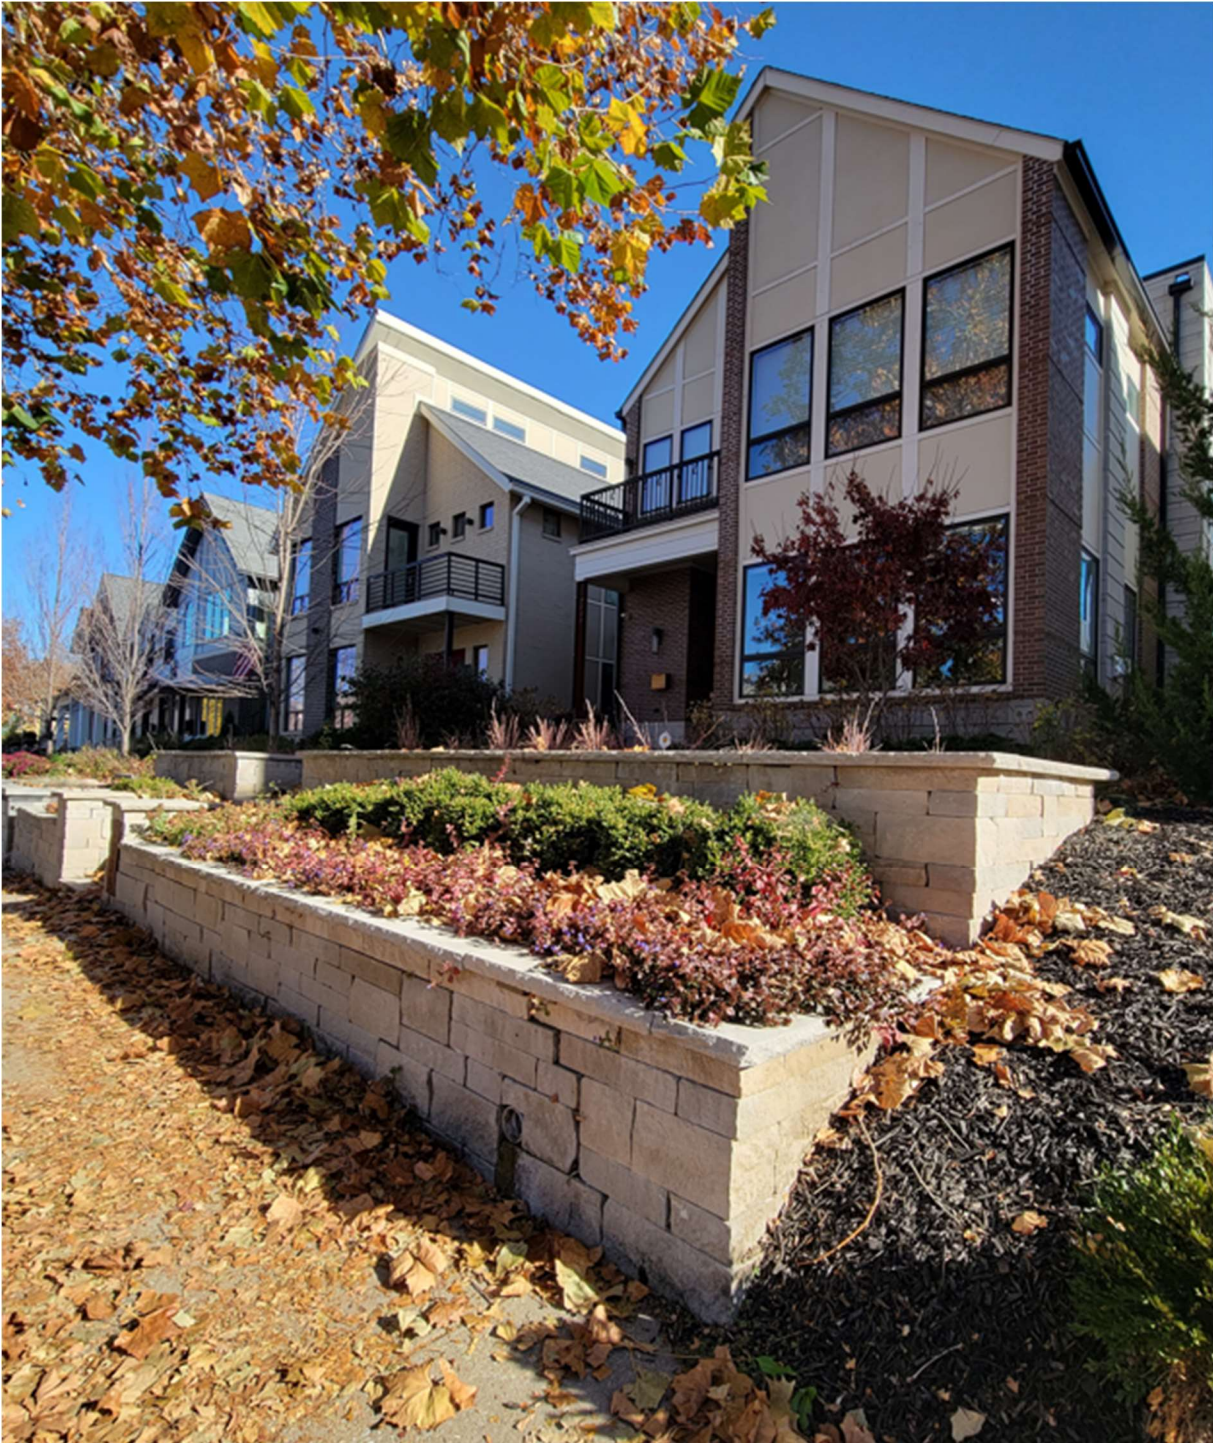
2039, 2043 & 2047 N Delaware – 3 contiguous lots with retaining walls at front
